# The landslide at Tuve

by BENGT-ARNE TORSTENSSON\*, DSc

On November 30, 1977, between 4.05 and 4.09 pm, a huge landslide occurred in Tuve, located in the vicinity of the city of Gothenburg, Sweden. The landslide covered an area of 27 hectares. A total of 65 homes was affected by the sliding soil masses. Some houses moved as much as 180m. The landslide claimed nine lives.

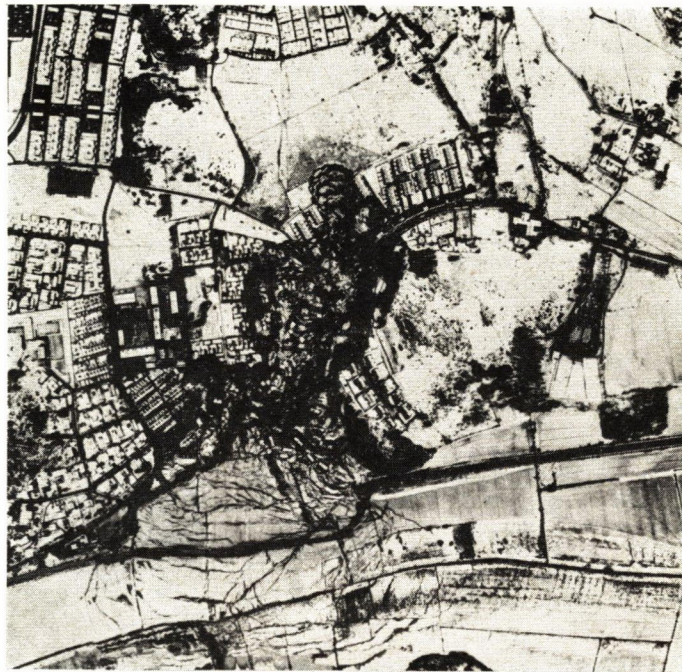
Fig. 1. The landslide in Tuve covered an area of 27 ha. In the upper "active" zone of the slide, the original ground surface sank a maximum of 10m. In the lower "passive" zone, the original soil was pressed upwards a maximum of 5m due to the energy of motion of the sliding soil masses. The volume of soil involved in the slide can be estimated at 3-4 million  $m^3$ .

slide started in the intersection between Tuve Kyrkväg and the small stream which ran through the area. After this initial failure the slide rapidly spread towards the sides and backwards. The total area of the landslide is about 27ha (Fig. 1).

In the upper "active" zone of the slide, the original ground surface sank a maximum of 10m. In the lower "passive" zone, the original soil was pressed upwards a maximum of 5m due to the energy of motion of the sliding soil masses. In the "passive" zone the ground heaved a maximum of 5m.

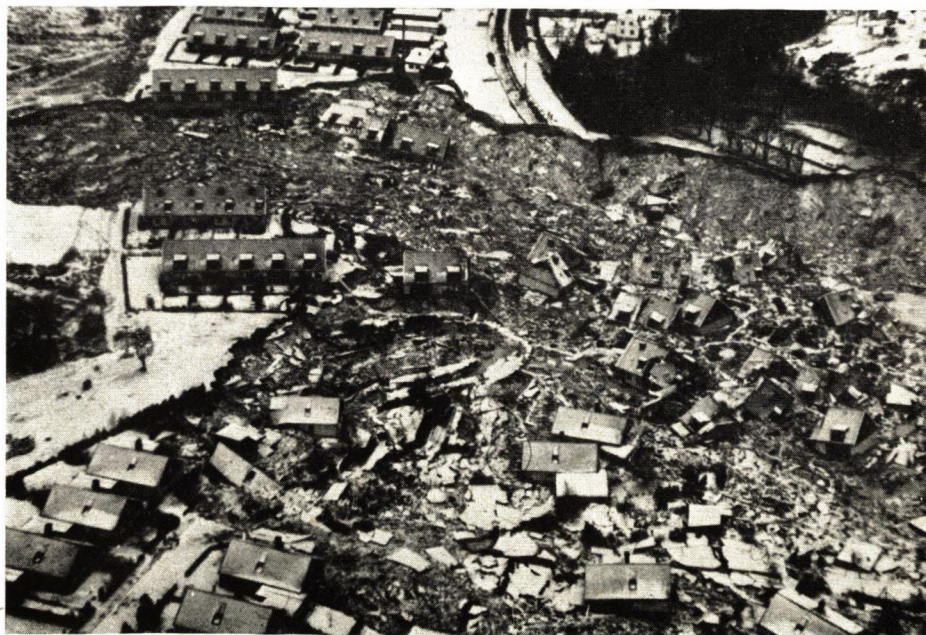
Fig. 3. Aerial view of the slide area

The landslide occurred in the afternoon when it was just getting dark and as a result the rescue work was difficult and dangerous (Fig. 2). On the following morning, the daylight exposed the extensive nature of the disaster in Tuve (Figs. 3 and 4) — 65 homes were carried away by the sliding clay masses, several houses had moved 100m to 180m, and close to the edge of the slide, about 30 houses sustained damage of differing degree.

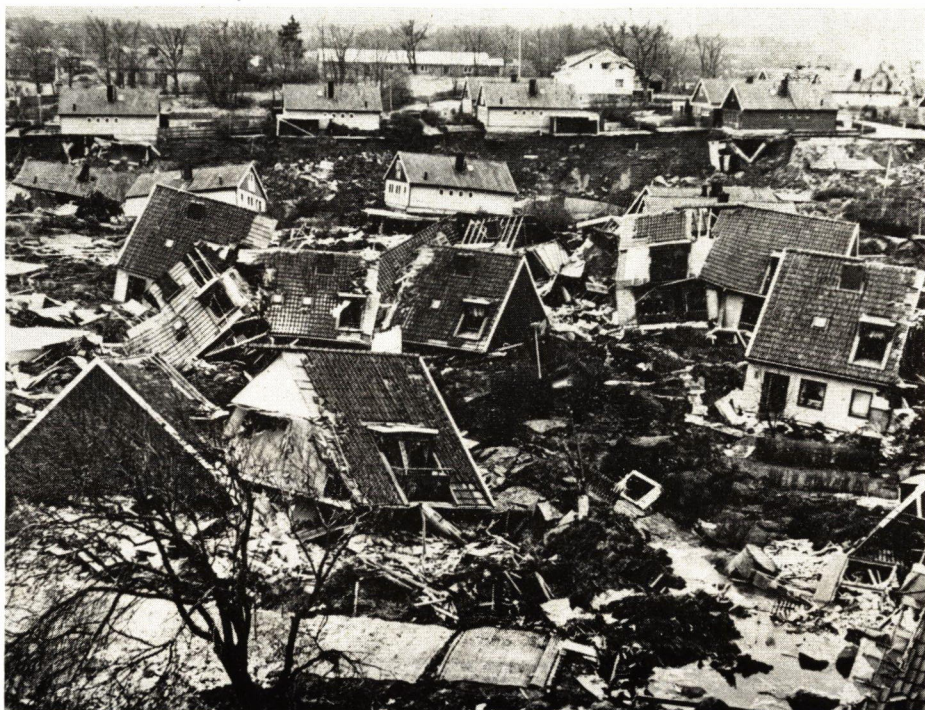
Fig. 4. The total damage costs for the landslide are estimated to be about 140 million Swedish crowns

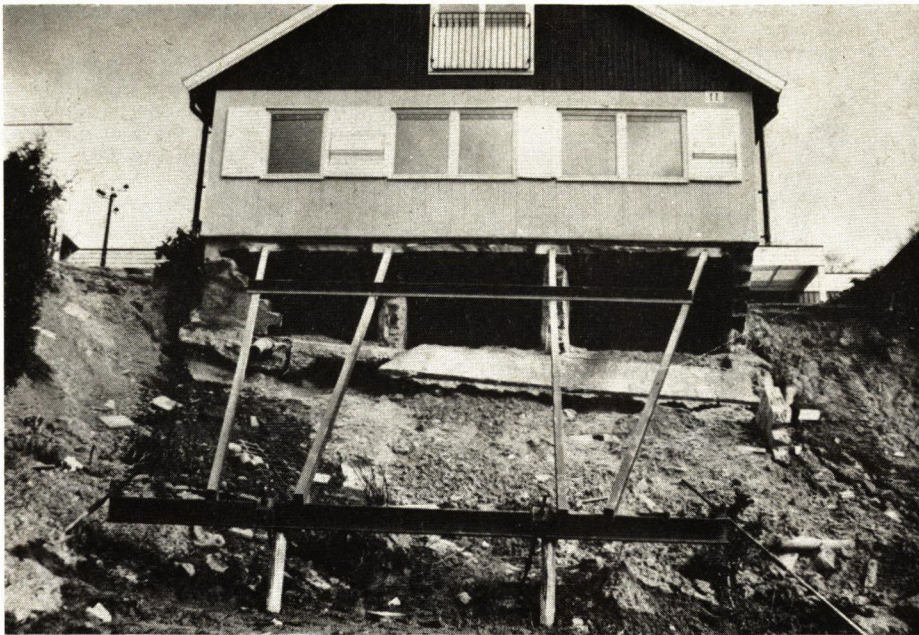
Fig. 7. Temporary struts supporting a building which is hanging over the edge of the slide

Various temporary measures were taken to save some of the buildings that remained on the edge of the slide (Fig. 7).

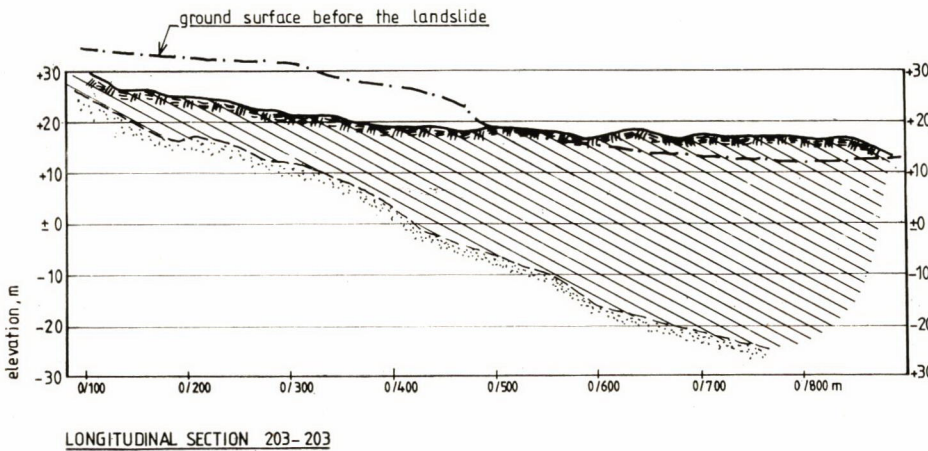
Fig. 8. Longitudinal section through the landslide. The thickness of the clay layer increases gradually towards the passive zone of the landslide. In this zone the depth to firm bottom is about 40m

The thickness variations of the clay within the slide area were determined by some 500 soundings. The depth to firm bottom increases gradually eastwards. To the north-west of the slide area, the thickness of the remaining clay varies from about 2-8m. In the central part of the slide area, the depth to firm bottom is about 20m. Within the passive zone of the landslide, the clay reaches a thickness of about 40m (cf. Fig. 8).

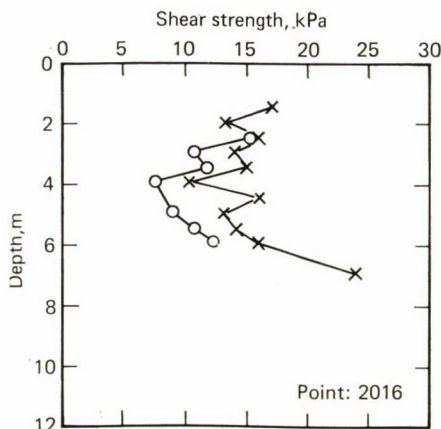
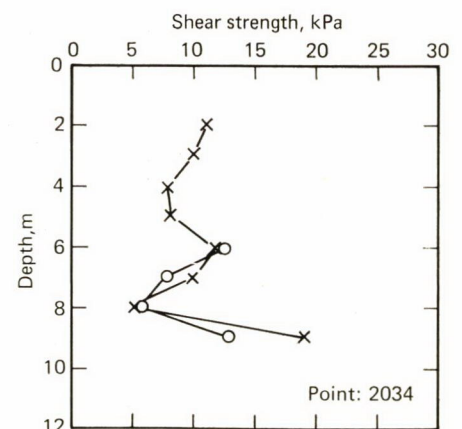
○—○ Max. shear stress in slow vane tests, time to failure 17h  
 ×—× Max. shear stress in ordinary vane tests

Fig. 11. Results of special field vane tests which were carried out in order to study the influence of strain rate on the shear strength values

shear stress was of the order of 17 hours. For example, at point 2016, where the clay had only been moderately disturbed by the landslide, the results showed that the strain rate had a pronounced influence on the mobilised shear strength (see Fig. 11a). At point 2034, however, where the

clay was severely disturbed, the results showed that the influence of strain rate on the shear strength had almost vanished, (cf. Fig. 11b).

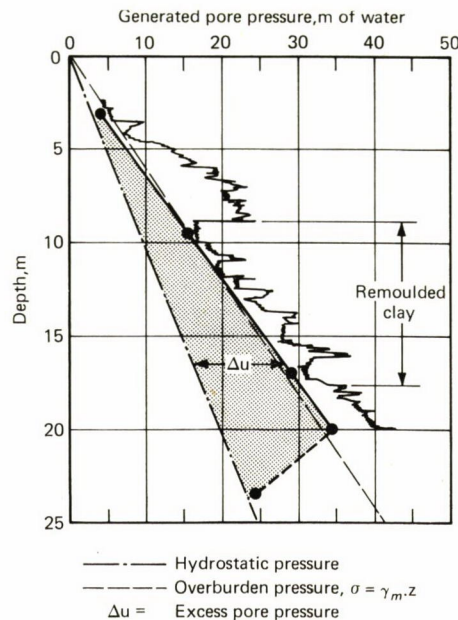
Fig. 13. Pore pressure sounding diagram for a soil profile in the "active" zone of the slide area. At depths greater than 10m the results of the pore pressure sounding indicated the presence of several zones of weakness in the slide masses; i.e. in these zones the generated pore pressures were at a minimum equal to the static pore pressure

When making pore pressure soundings in the slide masses, the presence of zones of remoulded clay are registered on the sounding diagram as sudden pressure drops. From the pore pressure sounding diagram shown in Fig. 13, it can be seen that within the depth interval of 4-9m there is a block of relatively undisturbed clay (i.e. high excess pore pressures are generated in this zone). At greater depths the results of the pore pressure sounding

show that the slide masses contain several zones of weakness. In fact, the generated pore pressures are at a minimum equal to the static pore pressure. This indicates that the shear strength of the slide masses is locally equal to zero. The presence of weakness zones means that the slide masses may have a very low shear strength irrespective of the depth below ground surface.

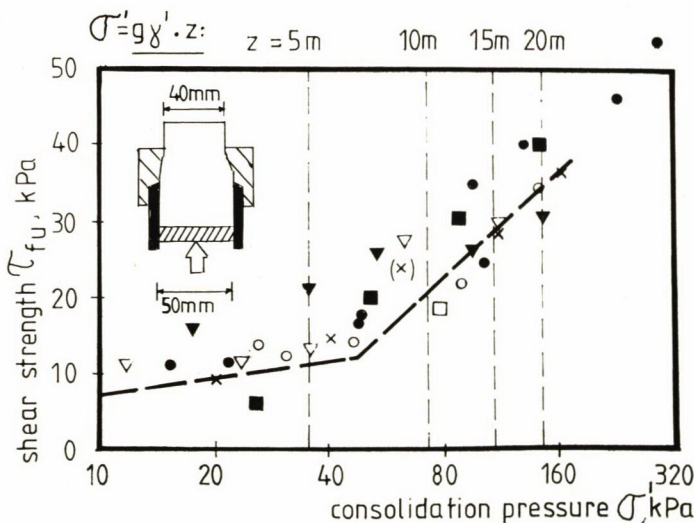
Fig. 14. Undrained shear strength values, consolidation pressure — results from tests on 34 reconsolidated samples from the 3-13m depth intervals

The tests were made on samples having an initial shear strength of 5-8kPa. Before testing, all samples were given a well-defined degree of distortion by pressing them through a conical piece of pipe, resulting in an area reduction of the sample of 35% (cf. Fig. 14). In cases where the samples were already severely disturbed in-situ, this treatment did not result in any further reduction of the shear strength. Altogether 34 samples were consolidated to different effective stress levels varying from 20-160kPa. The subsequent shear strength measurements showed that the ratio  $\Delta\tau/\Delta\sigma'$

in which  $\Delta\tau$  = increase in shear strength  
 $\Delta\sigma'$  = increase in effective stress  
 decreases with an increasing stress level. Within the stress interval of 45-160kPa, the ratio  $\Delta\tau/\Delta\sigma'$  is on average equal to 0.20. This value is in good agreement with the empirical relation given by Hansbo (1957)

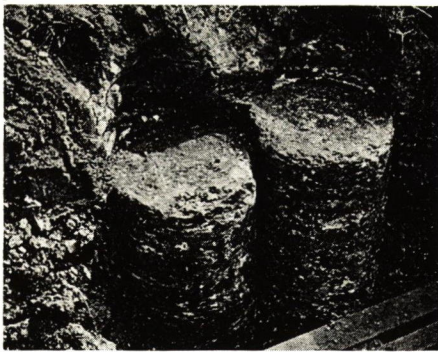
Fig. 16. Lime columns with a diameter of 0.5m

One possible solution to a quick stabilisation of the slide masses would be the use of the so-called lime column. The lime columns (Fig. 16) are manufactured in-situ by mixing unslaked lime and clay. The LPS equipment, developed and marketed by Linden-Alimak, consists of a mixing tool mounted on a special carrier, the unslaked lime being kept in a storage tank on a trailer towed behind the carrier (see Fig. 17).

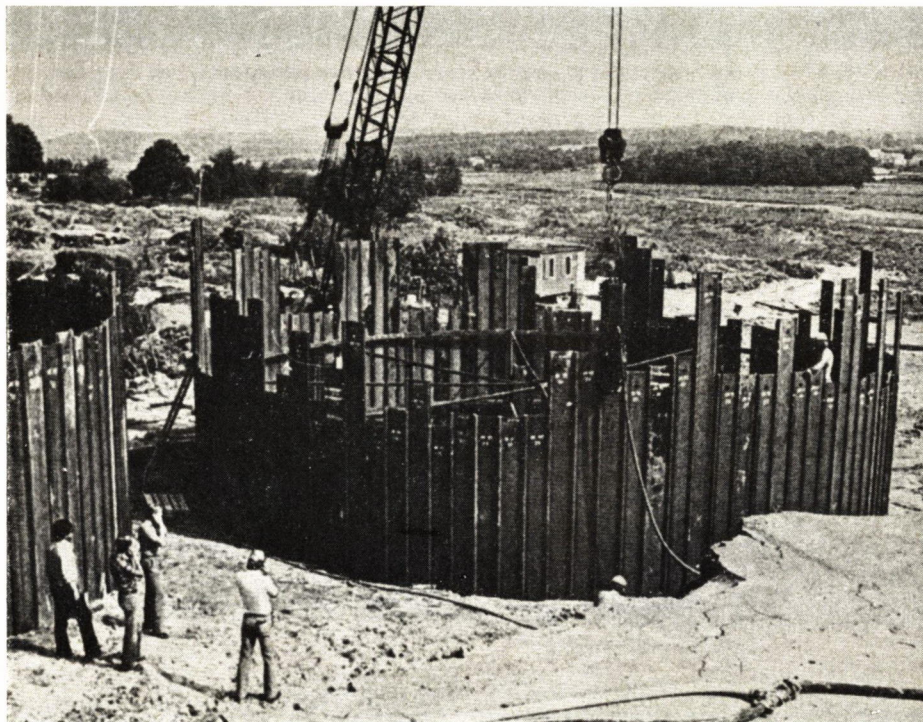
Fig. 27. The circular sheet pile walls were primarily constructed to prevent local stability problems in the clay during placement of the road embankment

The sheet pile walls were constructed primarily to prevent local stability problems in the clay during placement of the road embankment. The aim was that the lime columns would accelerate the consolidation of the clay so that the final paving of the road could be done only a few months after the construction of the embankment. The shear strength increase in the clay layer due to consolidation under the weight of the road embankment, together with the reinforcing effect of the lime columns, would give an acceptable factor of safety for the future

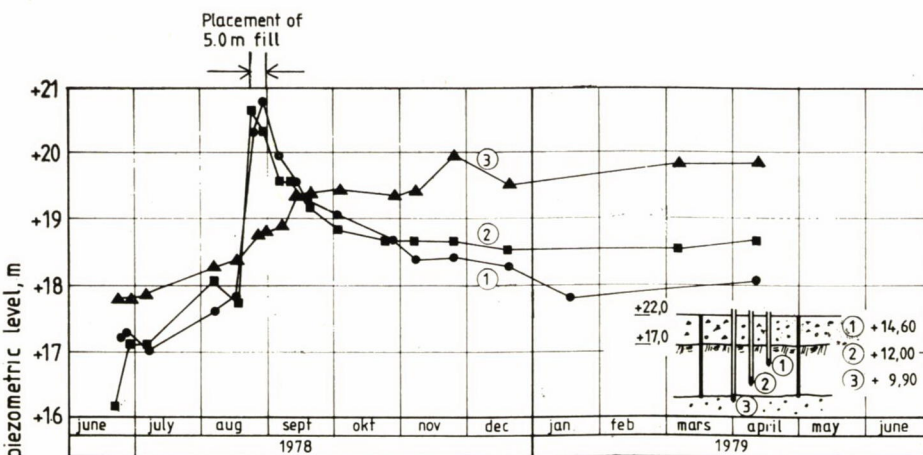
Fig. 28. Results of pore pressure measurements at different depths in the lime column stabilised soil. The results of the measurements demonstrated that the lime column functioned both as a reinforcing element and as an effective vertical drain

Fig. 28 summarises the results of the pore pressure measurements. During the construction, in August, 1978, of the 5m thick road embankment, the pore pressure in the clay layer increased by 30-40kPa. This pore pressure increase corresponds to about 40-50% of the weight of the road

embankment. Thus, the measurements indicated that the lime columns carried about 50% of the embankment weight. After completion of the filling works, the excess pore pressure started to dissipate rapidly. This result shows that the lime columns effectively functioned as vertical drains. In about 2-3 months the consolidation process in the clay layer was completed — a result that must be regarded as most satisfactory.

The measurements also showed that in the permeable soil beneath the clay layer the original piezometric level was re-established due to the construction of the road embankment, cf. curve 3 in the pore pressure diagram.

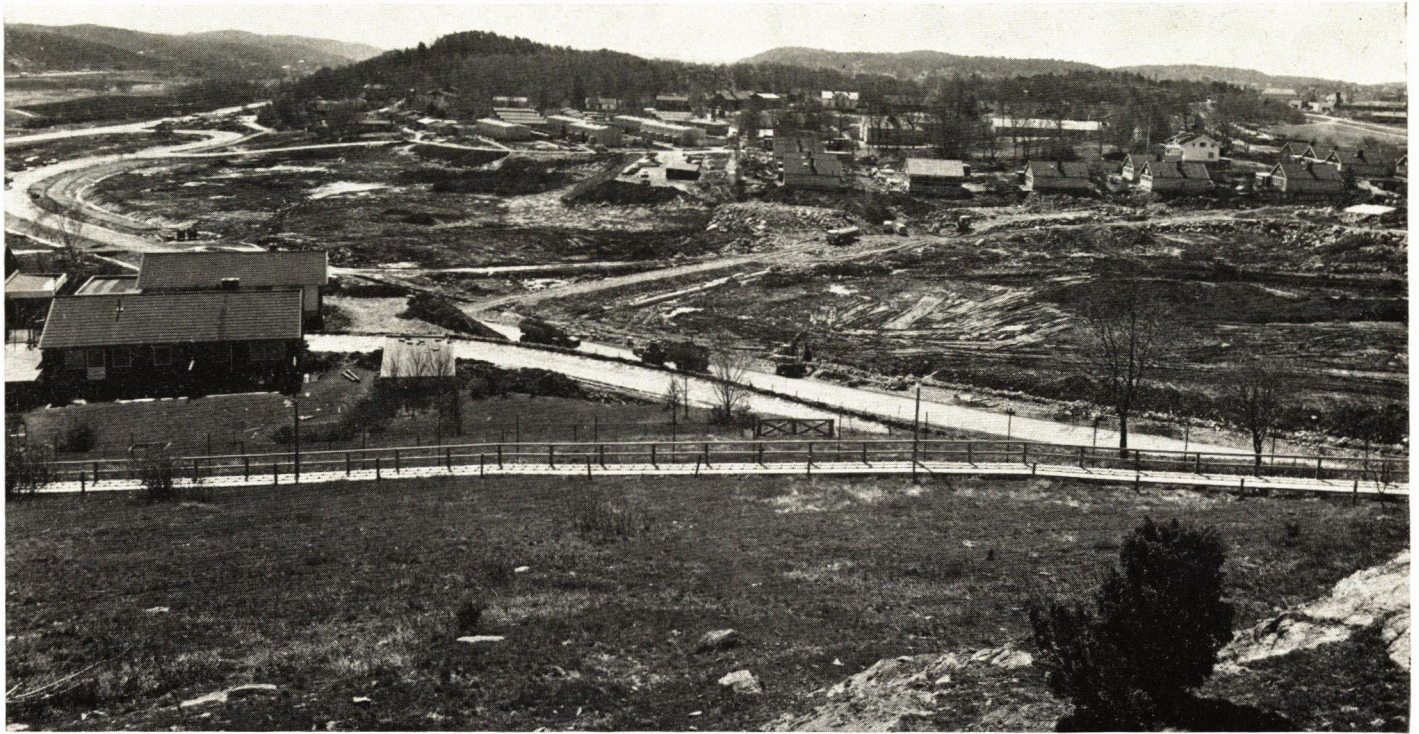
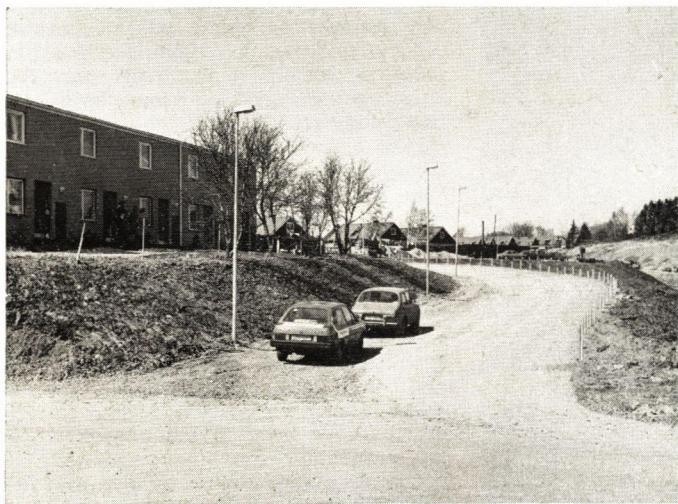
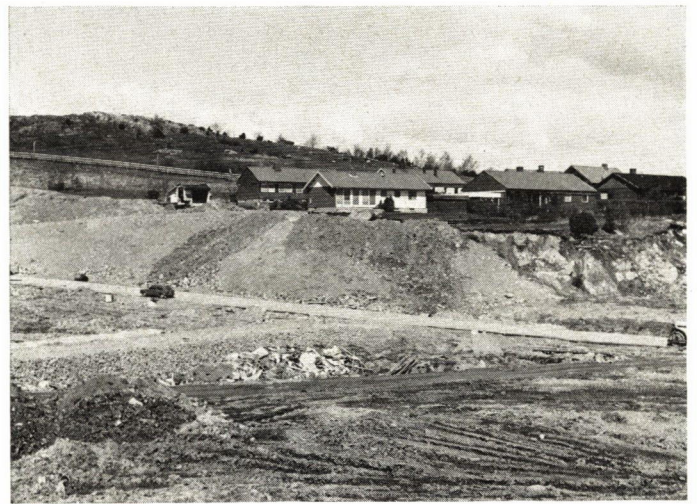
Fig. 29 (above and below). 18 months after the landslide (September 1979) almost all scars of the landslide have been removed. In general, the area was completely stabilised and reconstructed by the end of 1979

Some 18 months after the landslide almost all scars of the slide had been removed (Fig. 29). On the whole, the area was completely stabilised and reconstructed by November 1979.
