## Ground treatment to improve tunnel progress on the Channel tunnel marine drives

By JD Crawley<sup>1</sup> and C Pollard<sup>2</sup>

### Synopsis

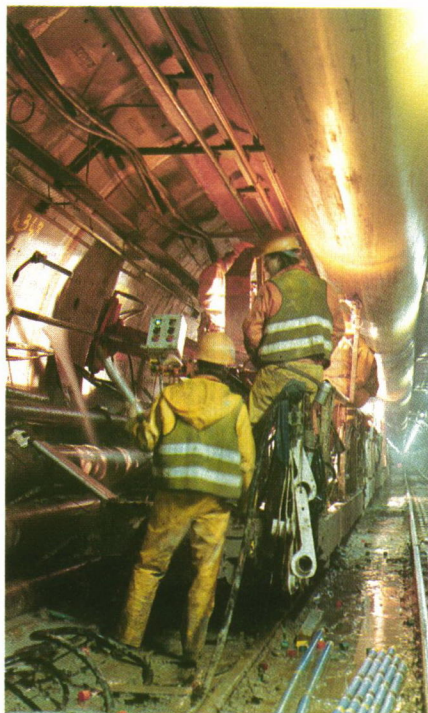
Picture 1: Drilling train in the service tunnel.

- Drilling train – four track mounted rotary drilling rigs, TàM sleeve grouting station and TàM materials storage.
- Grouting train – six grouting pumps and recorders, TàM packer winders, Silacsol proportioning mixer and materials storage. Control drilling rig for post-treatment permeability testing.
- Supply train – tanks and pallets for replenishing TàM and Silacsol materials and spare parts.

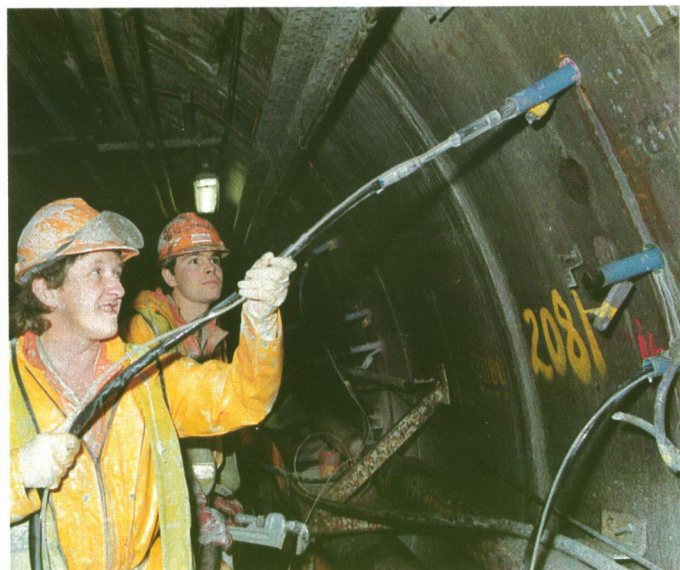
34 Picture 2: Inserting a tube à manchette PCC lined section.

Each of the pumps operated independently, discharging through a double-ended packer located with one packer above and one below the sleeve to be injected, see Figure 7. Injections were made systematically commencing at the further sleeve and progressing towards the mouth of the hole (Picture 2).

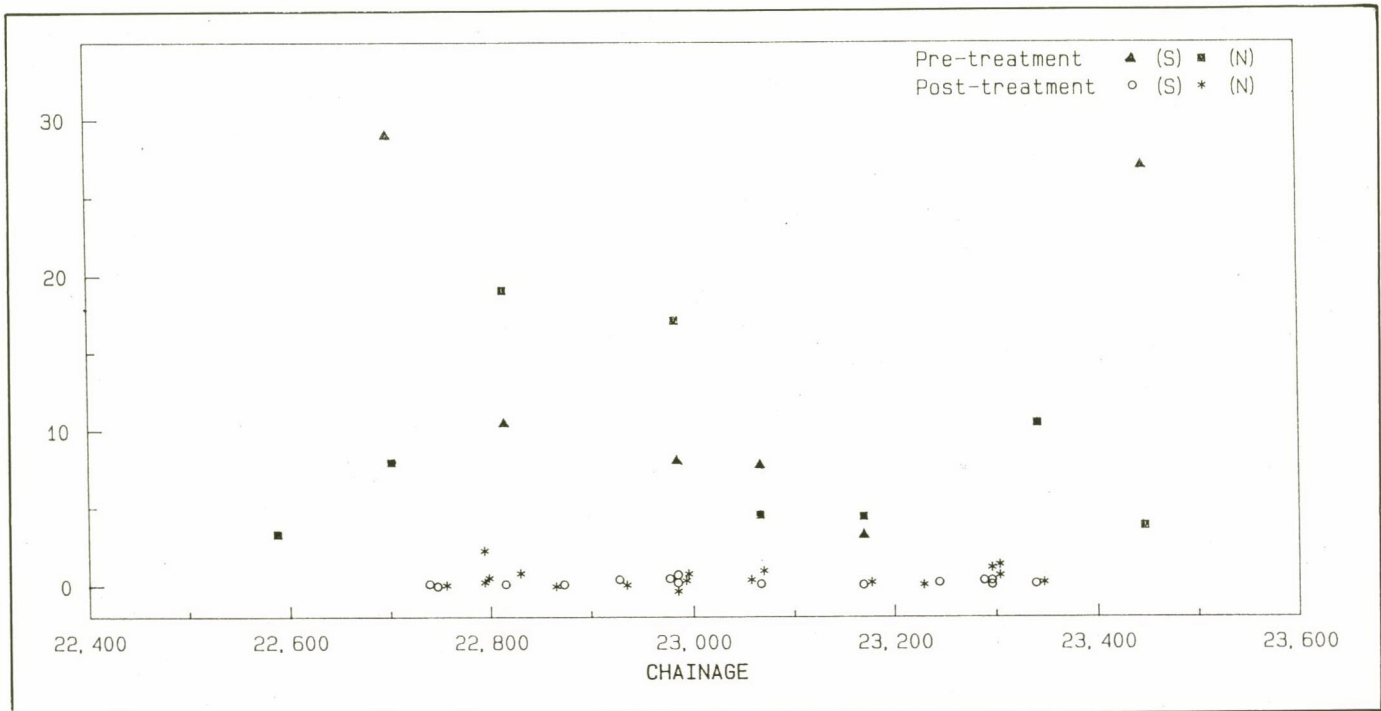
Figure 10: Side probe permeabilities before and after ground treatment.

Water testing was carried out a minimum of four days after treatment. The results, recorded as equivalent lugeon values, ranged from 0.08 to 1.4 lugeons – with a single 'high' value of 2.34 lugeons, see Figure 9. These rates can be compared with values of 3 lugeons to 30 lugeons prior to treatment, see Figure 10.

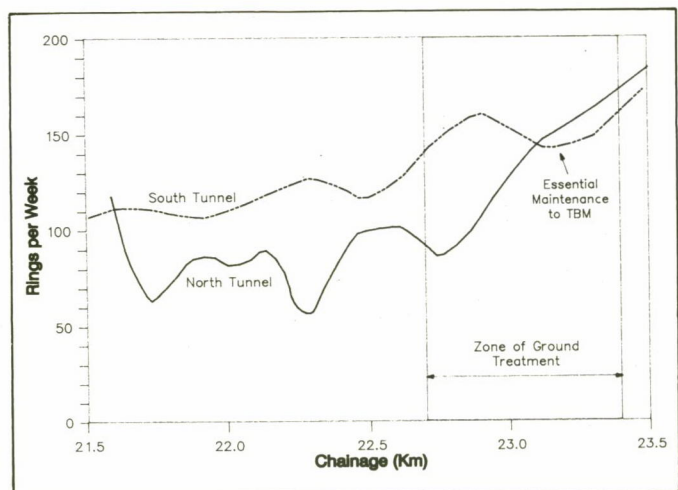
Figure 11: Running tunnel progress chainage 21.5 to 25.5.

While there are many factors to take into account, it is clear from the progress graphs that there was a very positive improvement in both the north and south running tunnel progress – instead of the anticipated greatly reduced production through the area of poor ground between chainage 22 700m and 23 400m, see Figure 11.
